# ARCHITECTURAL RESTORATION

## The Hidden Treasures of the Carnegie Library at Alfred University

Problem: Damaged interior column capitals that had been covered up for decades

Solution: Recovery and restoration, on time and on budget

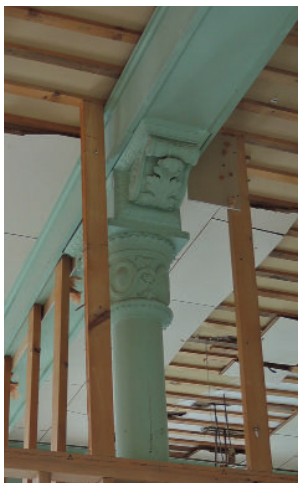
*"...we saw a beautiful iron column with a complex capital...it was like uncovering an Egyptian tomb."*

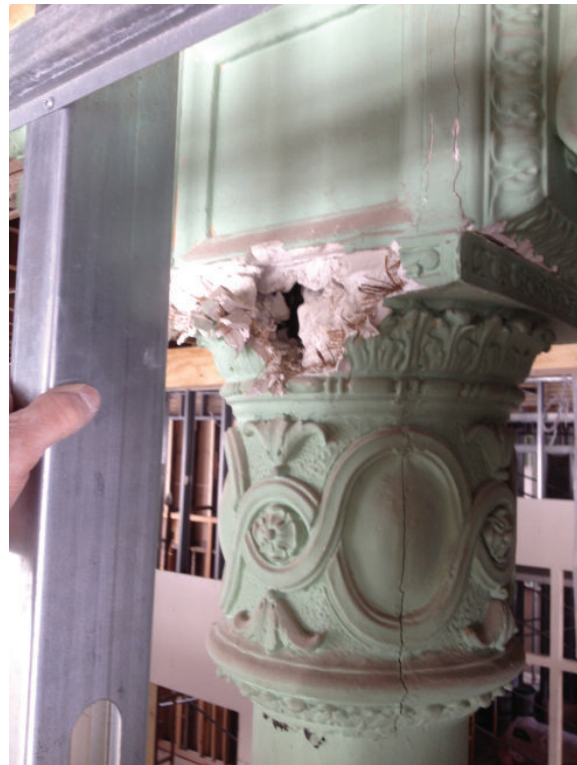
Hemenway said, "In the 1960s renovation, many of the intricate capitals had been damaged, and some were completely destroyed and removed. I knew we needed an expert in architectural restoration, so I contacted Scott Grove. He's a very creative problem solver and I wanted to talk to him about our options," Hemenway said.

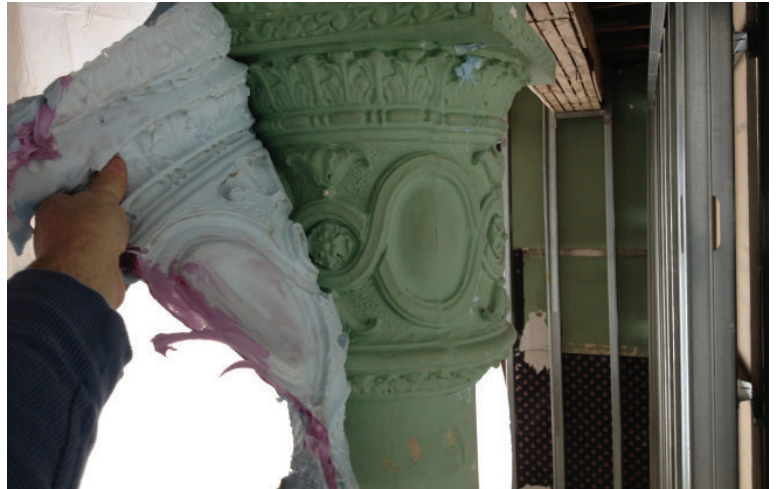
On-site mold removal

At Alfred, Grove photographed all the capitals, including the damaged ones, and realized that he needed only 180-degrees of one capital to create an entire 360-degree replacement piece. He said, "There was one capital that was in good enough shape to use for a mold, I did a minor hand-sculpting repair and refined some details. I took a flexible, silicone mold on site that captured the high detail and undercuts. I then brought it back to my studio to work under controlled conditions."

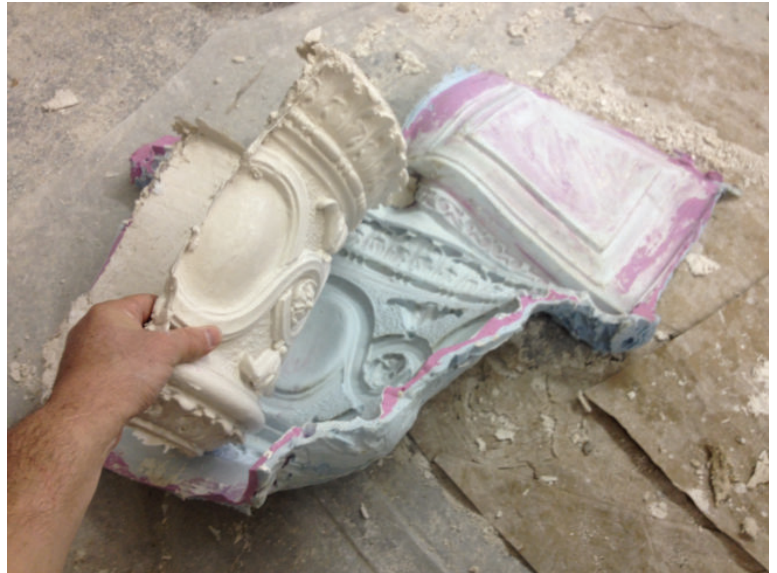
Final casting

From this original mold, Grove cast two completely new capitals. While reviewing the damaged ones, he documented a list of all the sections he needed to create new capitals, and then cast a few dozen parts to splice into the existing damaged ones.

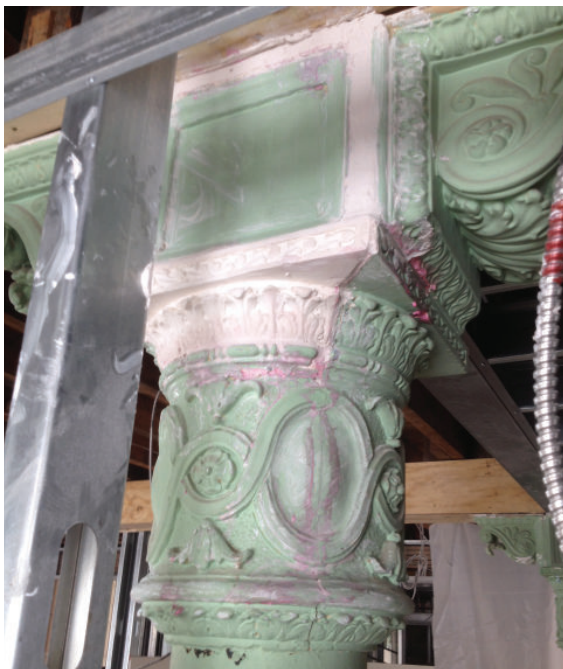
"It was a complex problem that needed to be solved: I had to work with the old plaster, some of which was damaged from water and physical abuse, and install new pieces that looked original," Grove added. "I consolidated surrounding material, spliced in the new elements, and feathered the components together to make them all look seamless."

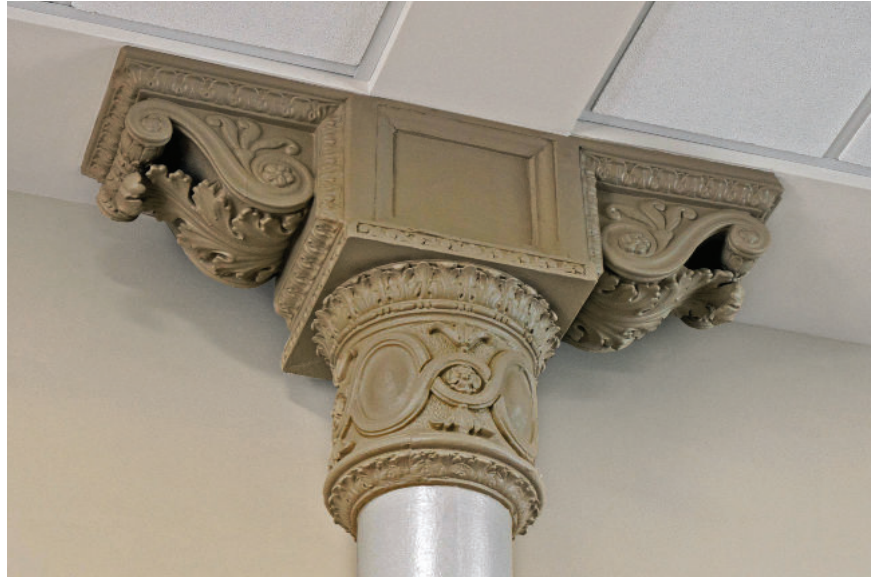
Once the capitals were installed, the ceilings lifted, and the room refreshed with new paint and lighting, the main room now has a wide open feel, with high windows on all sides. The impressive interior columns line the walls, each with capitals and brackets, with supporting beams that hold up the ceiling. The results are astounding.
